# Structure

Final Analysis Property Inspections LLC

## INTRODUCTION

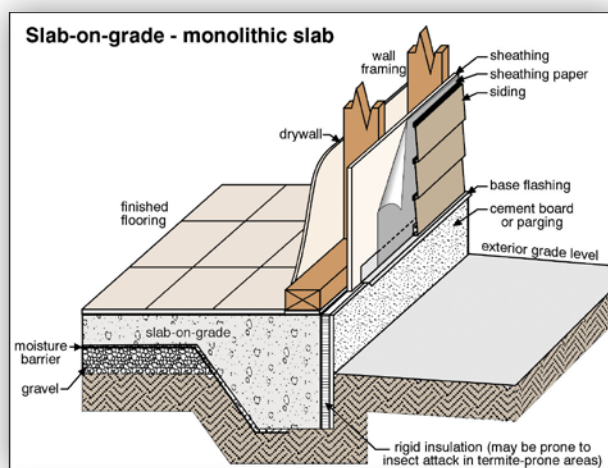
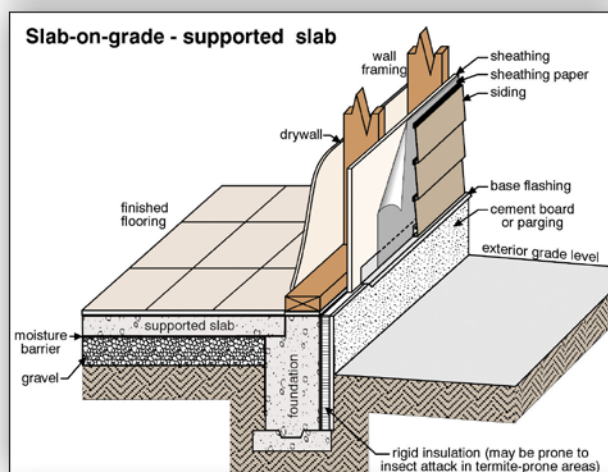
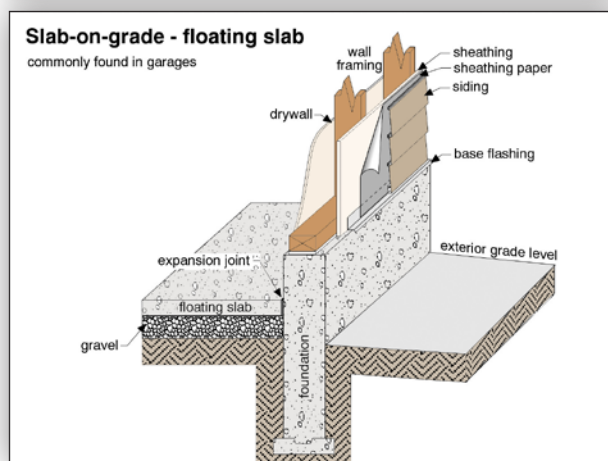
There are several types of slab-on-grade construction, including monolithic slab, supported slab, and floating slab. A monolithic slab is a concrete floor and foundation all poured as one. This can be thought of as a floor slab that is thicker around the edges.

A supported slab is not poured together with the foundation, but it does rest on the foundation. The footings and foundation wall are installed first, with a ledge at the top of the foundation to support the slab. Basement floor slabs are often supported slabs.

The floating slab is entirely independent of the foundation. The foundation is poured or built first. The slab is not supported by or connected to the foundation. This type of slab is common in garages.

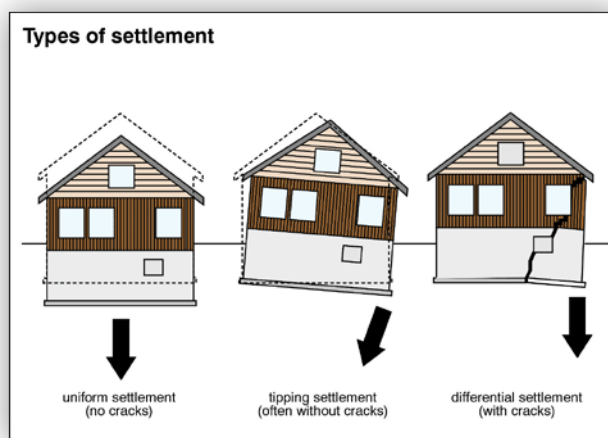
### SETTLEMENT – WEAK SOILS

Soils prone to compaction or movement do not support footings well. This includes recently disturbed soil. For example, if an excavation for a foundation is dug too deep, then backfilled to the correct depth, the disturbed soil under the footing is likely to compact over the first few years, resulting in building settlement.

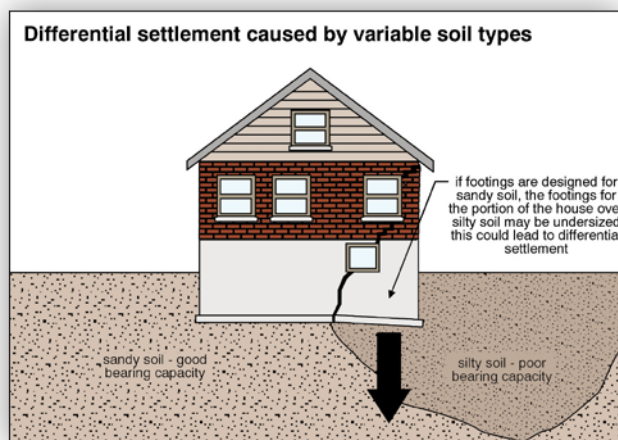
### SETTLEMENT – UNDERGROUND STREAMS

These may erode or weaken soil below the footings, causing severe building settlement. It is, of course, very difficult to locate and trace underground streams. They often flow only at certain times of the year.

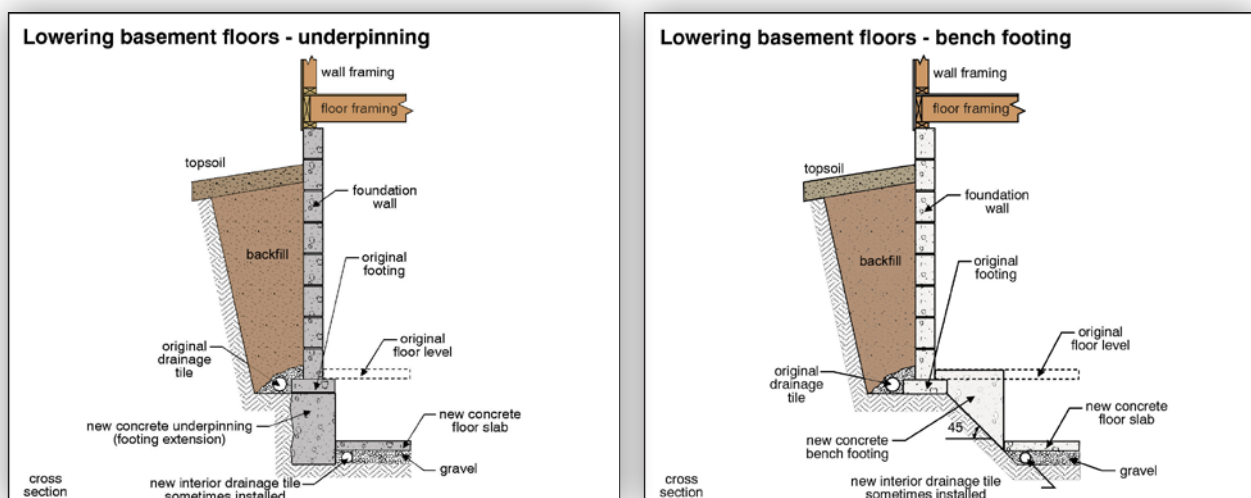
**SETTLEMENT/WALL FAILURE – LOWERED BASEMENT FLOORS** When a basement floor is lowered, the footings should be underpinned (lowered and, in some cases, enlarged). Alternatively, only the central section of the basement should be lowered, to avoid disturbing any of the soil near the footings. Depending upon how much the basement floor is lowered, the required clearance from the footings varies. A soils engineer is often consulted and a concrete curb (also called a bench footing or Dutch wall) may be needed around the inside edge of the footings to ensure they are not compromised. Building settlement and failure of foundation walls are both risks when lowering basement floors.

One of the dangers in lowering basement floors is the increased risk of basement leakage. Notice in the following illustrations how the drainage tile outside is no longer in the correct location once the floor is lowered. It is too high to be effective.

When excavation is done on the exterior, (e.g. for an addition or swimming pool) the footings can be damaged or undermined in a similar fashion.

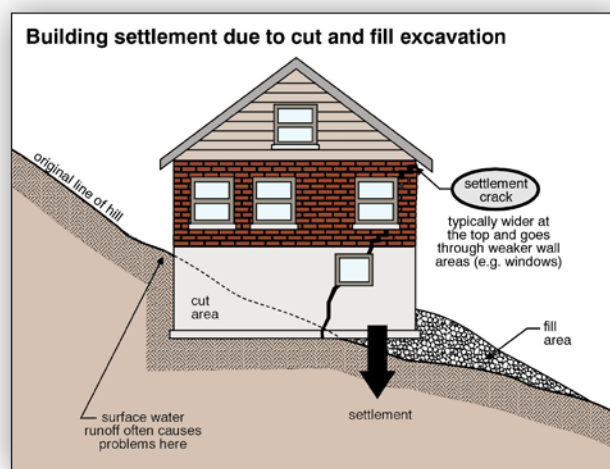
**SETTLEMENT – CUT AND FILL LOTS** Houses built on sloping lots may be more prone to footing and foundation failures. The chances of building on disturbed soil are increased on lots such as these. Efforts made to level and terrace the lot may result in soil being cut out of the hill to form a level terrace under the back half of the house. This soil is then used as fill in the adjacent area where the front half of the house is to stand. The downhill half of the house may be built on fill that may not be well compacted or may not be able to stay in place and support the house.

On sloping lots, large lateral earth thrust and hydrostatic pressure can be built up by the soil on the high side of the home.

On the downhill side, the footings may not be deep enough in cold climates. Frost heave can result where the footings are less than four feet below grade. The side of the house with the lower grade often has a walk-out basement, and chances of a footing being too shallow are greatest here.

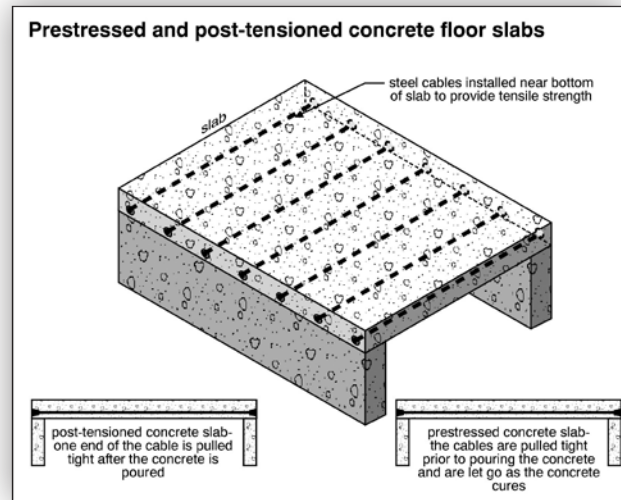
**EXPANSIVE SOILS AND SLAB-ON-GRADE HOMES** Where expansive soils are common, heaving soil below the slab can push the slab upwards at the center or at the perimeter, breaking the concrete and damaging utility lines. Where these soils are common, the slabs are sometimes post-tensioned. This means there are steel reinforcing cables laid within the slab and project beyond the slab edge. The cables are tightened after the concrete is poured to strengthen the slab, helping it resist the forces of the expansive soils. The slabs are sometimes thickened in places, often with beams running in both directions on the underside of the slab. These are called ribbed foundations.

The expansive soils below the slab are often saturated during construction before pouring the slab so the soils will be a maximum height when the slab is poured.

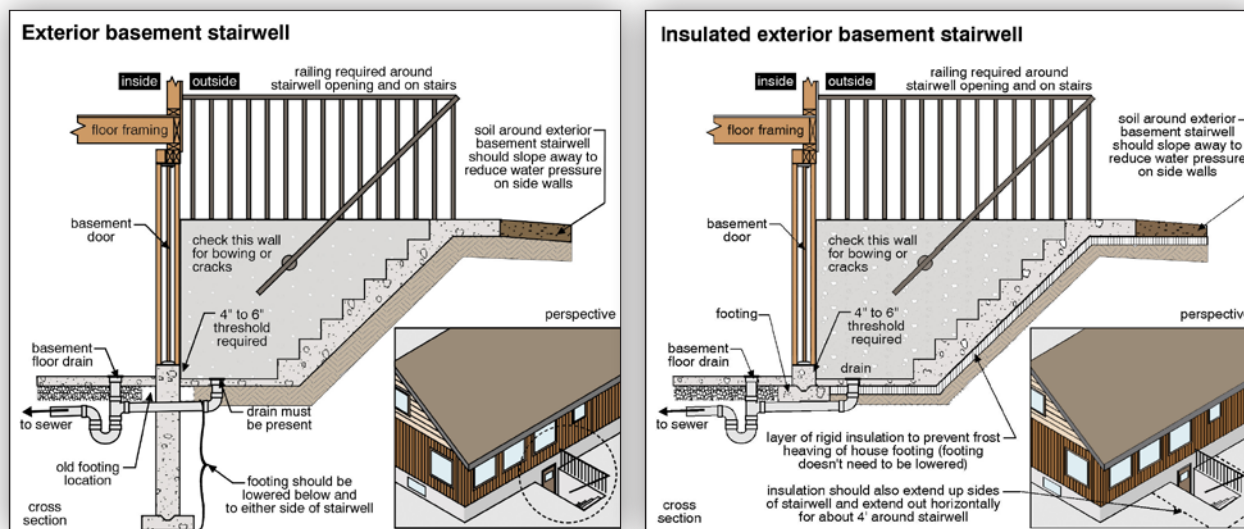
**FROST HEAVE – OUTSIDE BASEMENT STAIRWELL** Exterior basement stairwells may compromise the footings in cold climates. In order to be effective, the footings in cold climates must be below the frost level. When an exterior basement stairwell is added, the stairwell opening effectively lowers the exterior grade level, and also lowers the depth to which frost can penetrate. After the stairwell is in place, the frost can go several feet below the bottom of the stairwell opening. This can lead to frost heaving of the footings and the foundations.

A properly added exterior stairwell will include deepened foundations, or a completely insulated approach, to prevent frost penetration below the building footings.

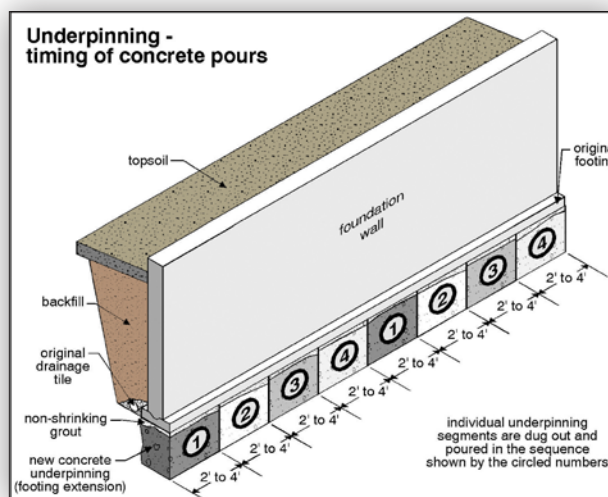
**REPAIRS – UNDERPINNING** The usual corrective action is to underpin the footings. This means digging under the existing footing, and adding a new footing wider and/or deeper than the original. This may have to be done in small sections on strip footings since one cannot excavate under the entire house at one time. Usually two to four foot sections are done at a time. This is very expensive work.

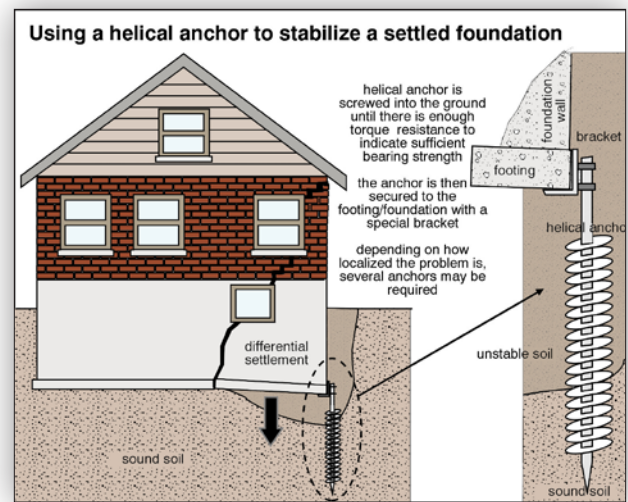
**REPAIRS – PILES AND HELICAL ANCHORS** In some cases, where the soils are moving or are likely to move, underpinning is not appropriate. Piles driven deep into the ground are an alternative, but may not be cost-effective for an existing building. Helical anchors are sometimes screwed into the soil to support failed footings.

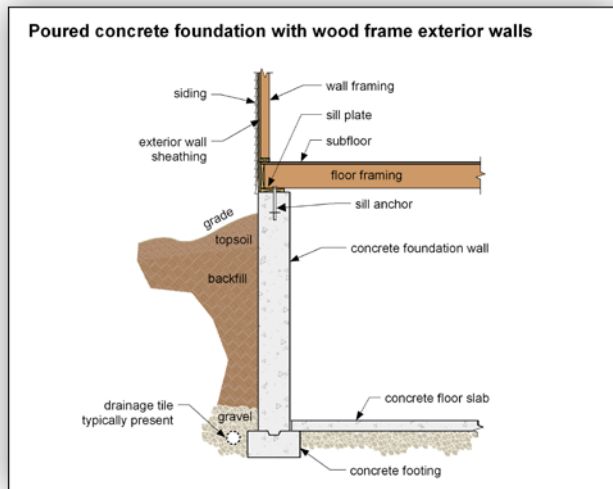
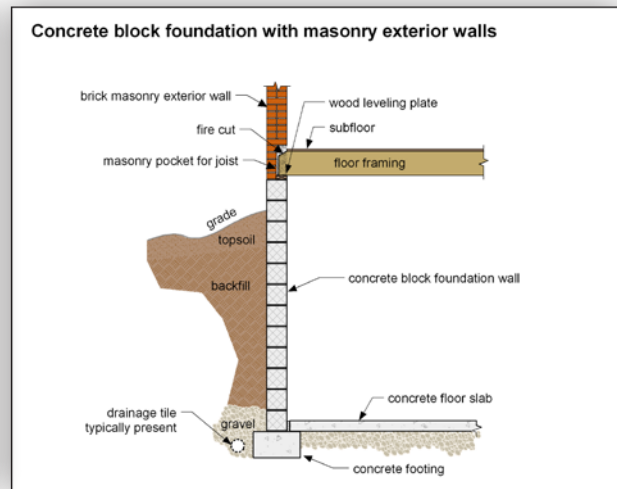
Two common foundation arrangements are illustrated below.

**COMMON FOUNDATION TYPES** Foundations may be continuous walls (stem walls), often made of concrete, masonry block or insulated concrete forms (ICF). Foundations may also be piers supported by pad footings.

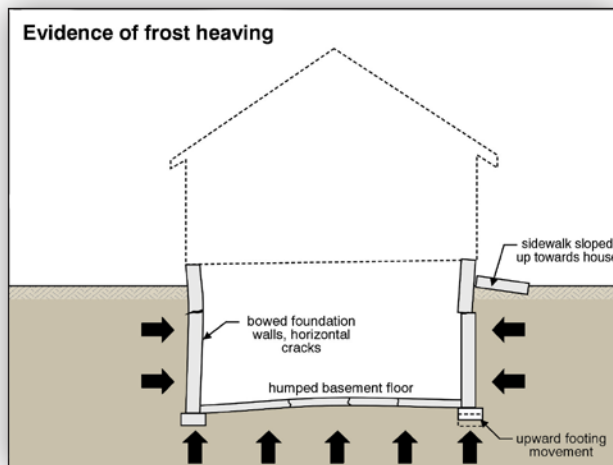
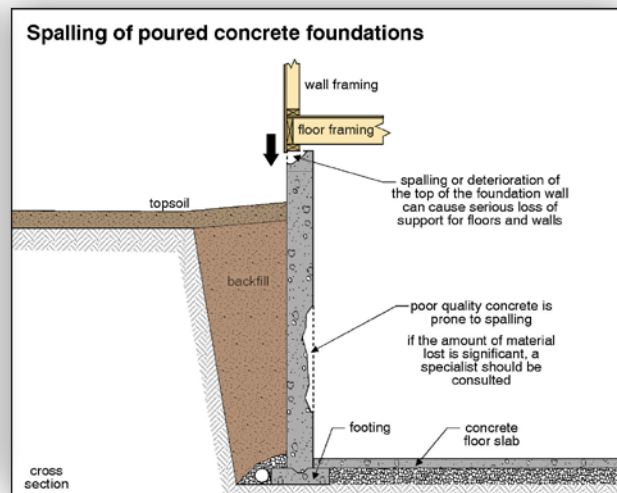
**CRACKS/ BOWING/ SPALLING** Foundation walls may crack, bow, spall or shift. Cracks may be due to shrinkage, settlement or lateral forces. Some cracks are serious while others are insignificant. Bowing is usually the result of lateral forces. Spalling indicates poor quality materials or chronic water problems. Some of the causes of foundation defects are outlined below.

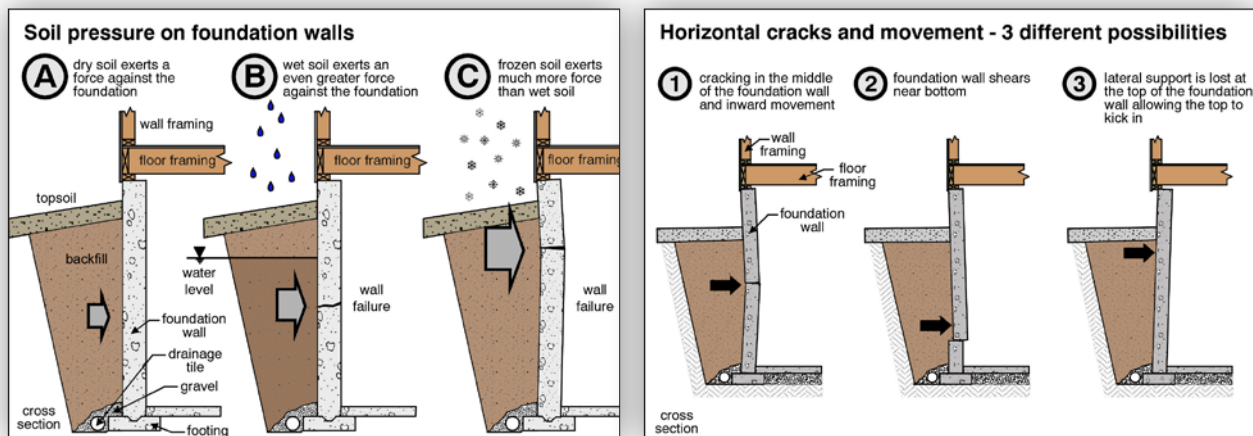
**INADEQUATE LATERAL SUPPORT** Basement and crawlspace foundations are really retaining walls, holding back the soil outside. If the foundations do not provide enough lateral support, they will deflect inwards. This may be the result of mechanical forces exerted during back-filling; back-filling with frozen soil (cold climates only); unusual frost development in the soil immediately outside the building (cold climates only); foundation walls that are too thin, too tall or do not have adequate reinforcement; or the house floor system does not provide adequate bracing for the top of the foundation wall. This last problem is common on the high side wall on a sloping lot. Both masonry walls and poured concrete walls can fail if not properly built.

**INWARD BOWING** Foundation walls that move inward can be repaired by tying them back from the outside, using ties and anchors. Alternatively, buttresses can be provided on the interior. These often are concrete or concrete block structures built against the basement walls. Steel beams are sometimes used. There are also modern structural fabrics that can be applied to strengthen walls. Another choice is to build a new foundation wall inside the old. In some cases the foundation is replaced.

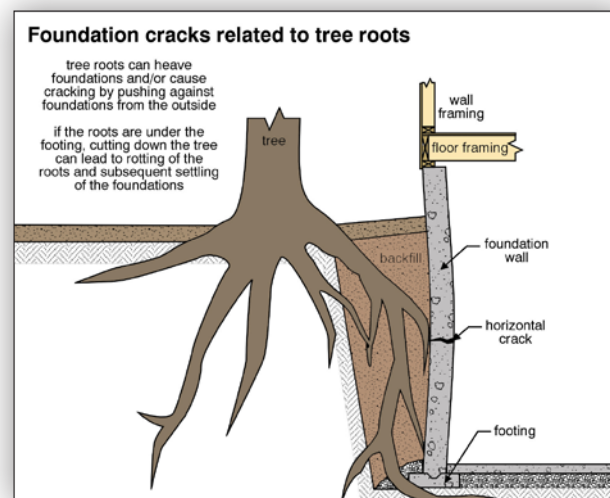
**BOWING/ CRACKS – TREE ROOTS** The force exerted by large tree roots on the foundation wall can lead to deflection of the foundations. Some soil types shrink considerably as they dry out. If a large tree draws water from such soils below a footing, the footing may drop as the soil compacts. In this case, the tree damages the house without actually touching it.

In the short term, tree root damage can be arrested by cutting down the tree and leaving the roots in place. Over the long term, the roots may be expected to rot, leading to soil settlement, resultant water leakage and, in some cases, building settlement. The roots may have to be removed.

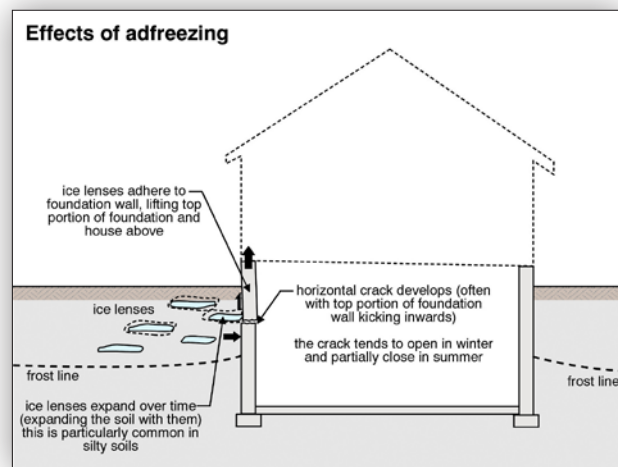
**ADFREEZING** Adfreezing is a phenomenon whereby damp soil on the outside of the building actually freezes to the building and as the soil heaves, it will lift the top part of the foundation wall. Horizontal cracks in foundation walls just below grade are typical.

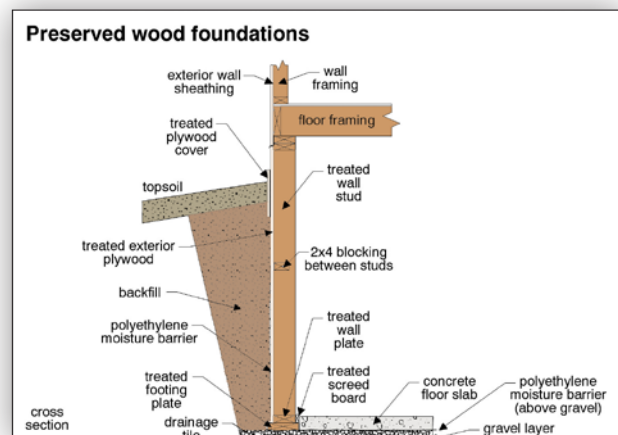
Preserved wood foundations were introduced in the early 1960s. Several thousand units have been installed. Life expectancies of the below-ground wood are estimated in the 50 to 100 year range, considerably less than many traditional building foundation materials. Some manufacturers offer 60 year limited warranties.

The wood is chemically treated to retard rot. Chemical treatment for wood used in foundations is more intensive than that typically used in wood for decks, fencing, etc. The wood foundations may rest on concrete or wood footings. With wood foundations, special care must be taken to ensure that the foundation is able to perform its retaining wall function (adequately resisting lateral forces).

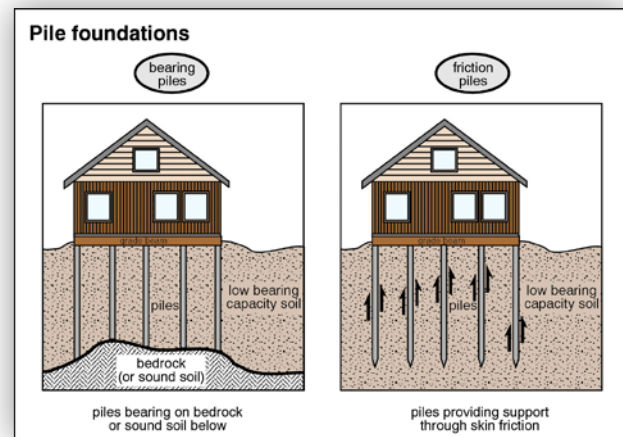
Piles are steel, wood or concrete columns driven into the soil. They are used in weak soils and may extend down through the poor soil, to reach a soil with good bearing strength. Piles may depend on friction between the sides of the pile and the soil for their support. They may also be point bearing at the bottom. The building itself rests on beams or walls that straddle the piles. Piles are expensive and once the building is up, there is often no way to know if piles have been used and where. Again, the presence or absence of building settlement is the only way to determine how successful the approach has been.

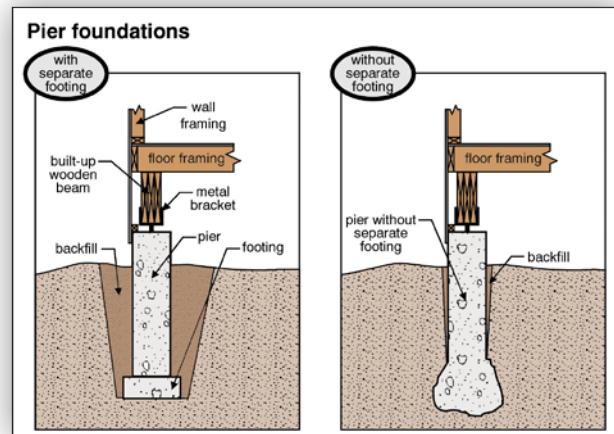
Piers may be stone, brick, concrete block, cinder block, or wood. Most of these materials behave in a similar fashion. Wood, of course, is the most vulnerable to rot and insect damage. As a rule, wood/soil contact is best avoided.

Concrete piers are often used with grade beams where expansive soils are an issue.

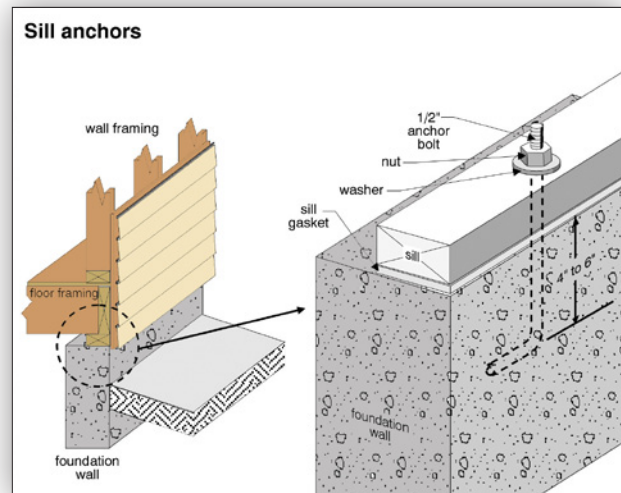
**ANCHORED TO FOUNDATION** Typically, the floor joists rest directly on and are secured to the sill. Sills should be anchored to the foundation. This is often accomplished using bolts anchored into the top of the foundation wall, passing through the sill and secured with a washer and nut.

In new construction, the sill is typically a wood framing member (2x4 or 2x6) laid flat. In older construction it may be a substantial wood beam (e.g. 8x8). Wood sills can support wood framing members but should not support brick or stone.

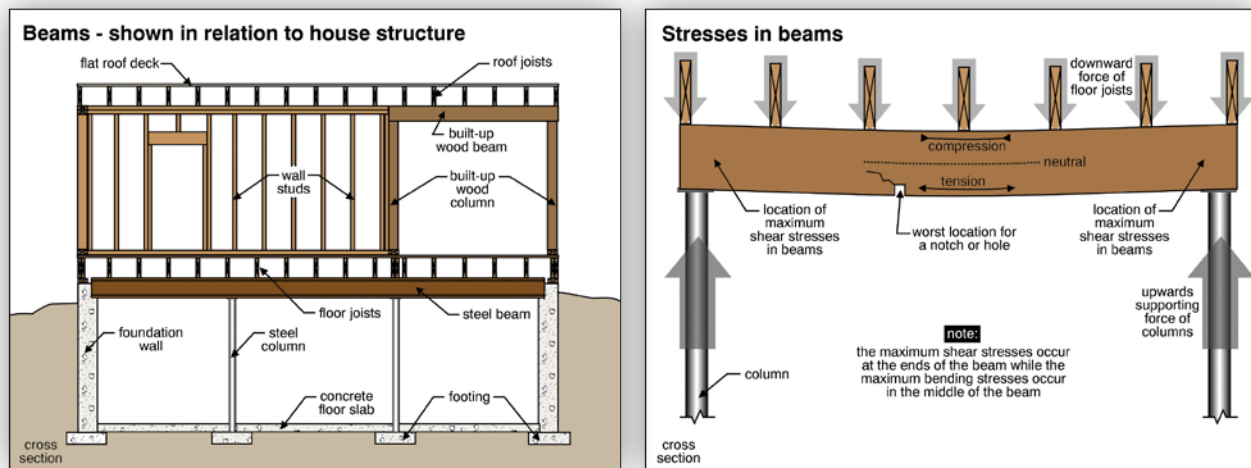
Beams carry floor and wall loads horizontally to the foundations, walls, columns or posts. Beams may be wood (solid, built-up or engineered), plywood or steel.

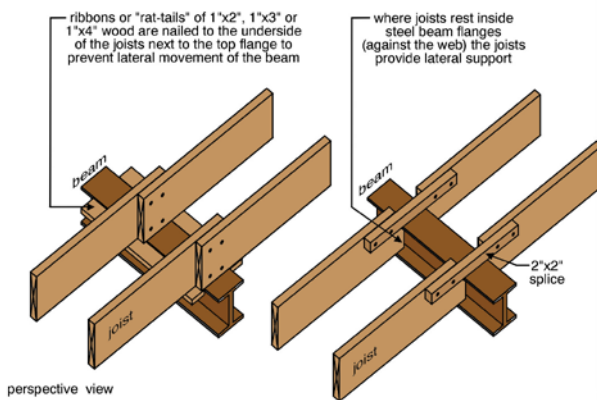
**Lateral support for steel beams**

**LATERAL SUPPORT** Lateral support for steel beams is typically provided by wood strapping secured to the joists. There are several ways to provide lateral support for wood beams. See the illustration below.

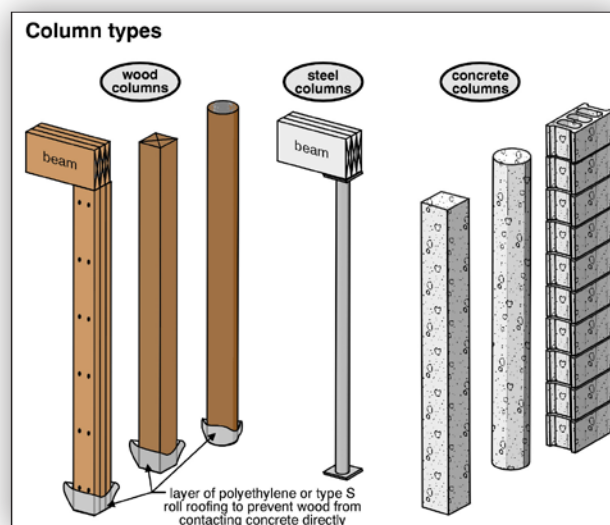
## 5.3 Posts and Columns

Posts or columns (two names for the same thing) carry the load of the beam vertically down to the footings. They may be brick, concrete block, poured concrete, wood, or steel.

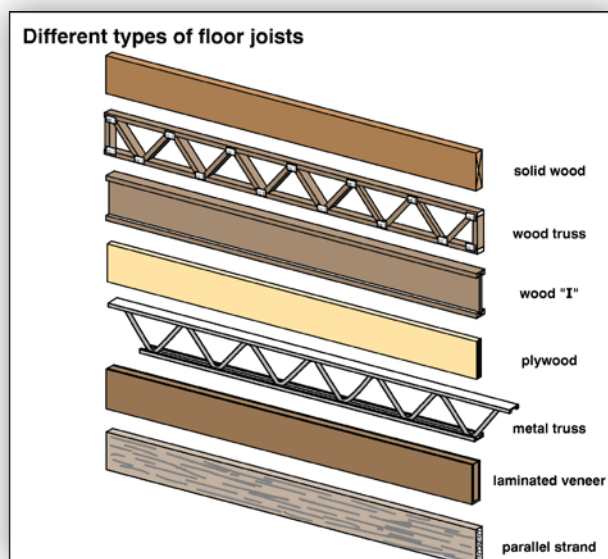
**JOIST STRENGTH** The strength of a joist comes largely from its depth. Doubling a joist by putting another of the same size beside it will double its resistance to bending. Doubling the depth of a joist increases its resistance to bending by eight times! For example, the equivalent strength (considering deflection only) of two 2x10s compared to four 2x8s can be compared by multiplying the base times the height cubed. It is interesting that two 2x10s are more resistant to bending than four 2x8s.

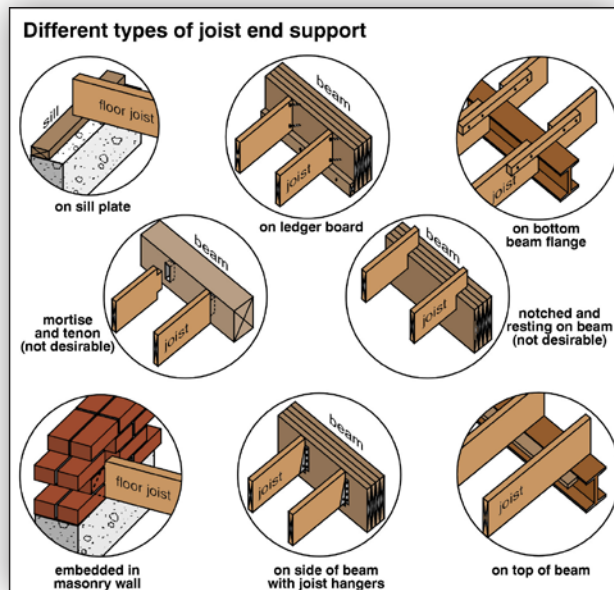
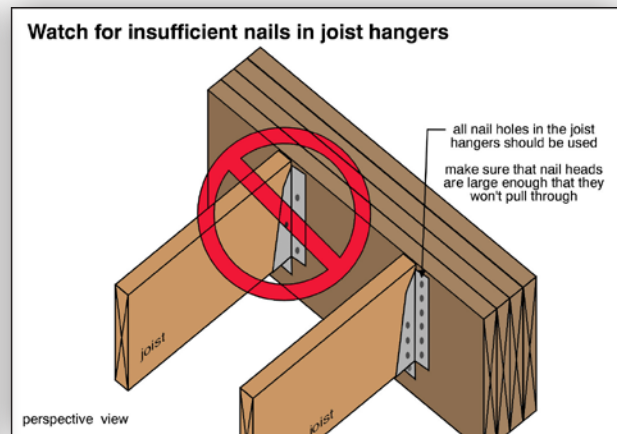
**JOIST HANGER PROBLEM** Metal brackets called “joist hangers” are used where joists cannot rest on a support. Here, the joists are cradled in and nailed to the hangers, which are secured to the side of a beam or header. Joist hangers may be undersized or inadequately nailed.

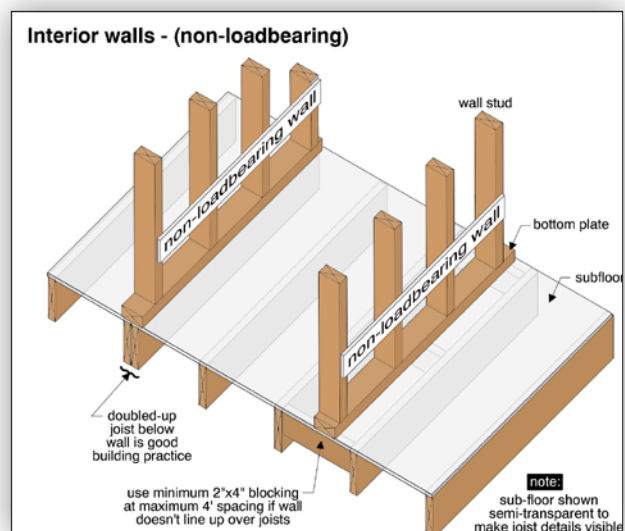
**SAG – JOISTS BELOW WALLS** Joists that see concentrated loads are more prone to sagging. A joist below a non-bearing wall should be strengthened, often by doubling it. Joists should not be used below load-bearing walls. Beams or bearing walls should be used here.

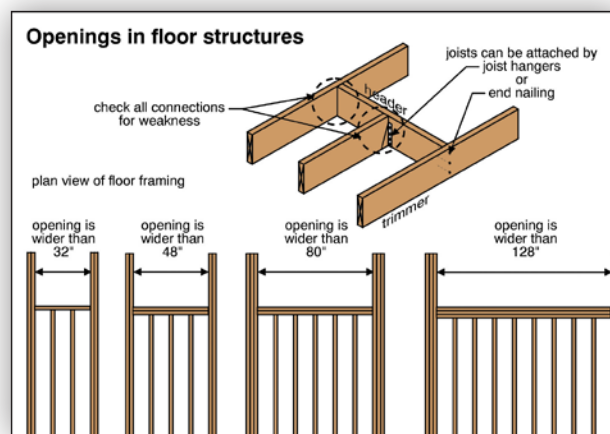
Normally, joists that cannot rest on a wall or beam are secured to a header. A header is typically made of the same size lumber as the joists (e.g. 2x8s). The header, which runs perpendicular to the joists, carries the load from the short joists (tail joists) over to trimmer joists. Trimmer joists are the joists on either side of the opening that run full length.

**POSTS** Posts can be provided at the corners of the opening to carry load from the header directly down to the floor. In this case, the trimmers could remain single. The header can also be supported with a bearing wall running under the header.

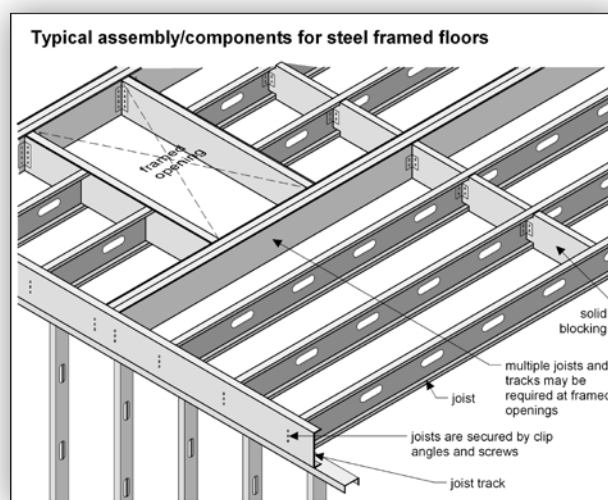
**HOLES/NOTCHES** Steel floor joists usually come with pre-punched holes for plumbing and electrical wiring, and should be installed so that these holes are aligned for easy installation of the mechanical and electrical systems. There are industry-specified requirements for other holes. Joists should not be notched.

**BRIDGING/ BLOCKING** Floor joists will twist and bounce under load if the tops and bottoms are not properly braced. The top is typically braced by the flooring. The bottoms can be braced with a drywall ceiling for example. Where there is no ceiling, the joist bottoms should be braced every 12 feet. This can be X-bracing, flat straps along the undersides and/or solid blocking.

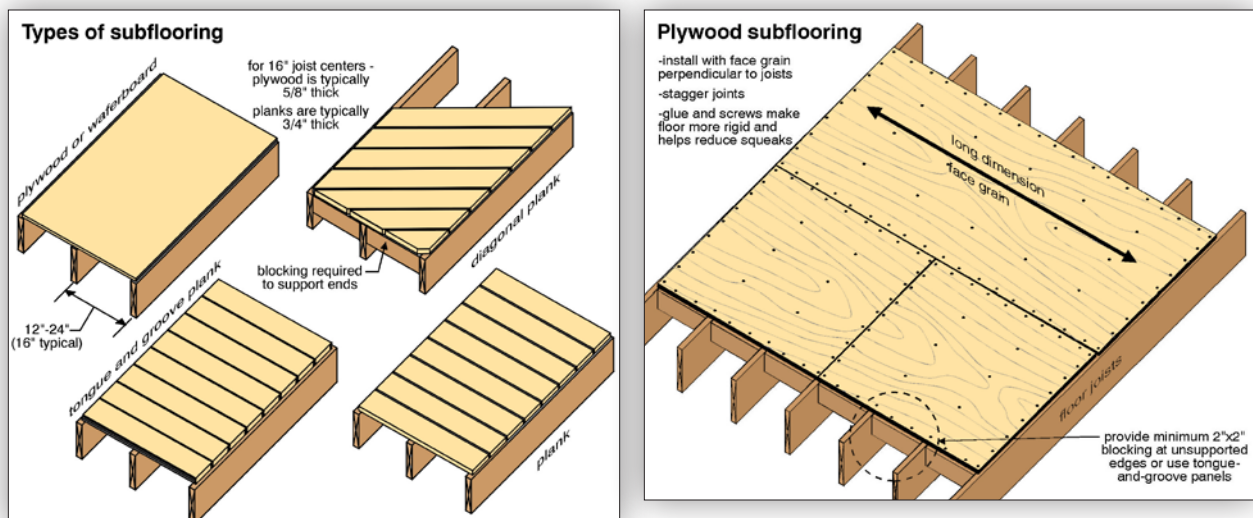
Sub-flooring transmits the live loads of the people and furnishings to the floor joists. Sub-flooring may be covered with a finish flooring material or may serve as a finish flooring itself.

One-inch thick wood boards were used as sub-flooring until roughly the 1960s. More recently, plywood and waferboard have been used. Thin concrete subfloors are less common.

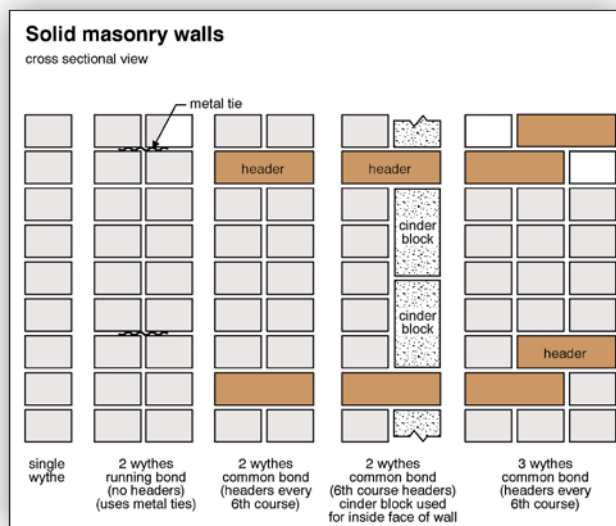
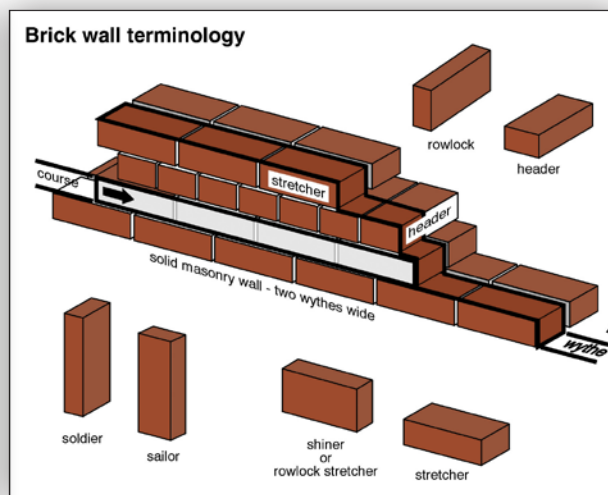
**IDENTIFICATION** In most cases, a solid masonry wall can be identified by the header courses (rows where the brick is turned end-wise to lock the inner and outer wythes of the wall together). This is done every five to seven courses (rows) up the wall. Sometimes every brick in the course is turned end-wise. Often, only every other brick is turned, and sometimes the pattern is random. In most cases, however, there are at least some of the units that are turned in every fifth, sixth or seventh course.

Metal ties or specially sized bricks can also be used to join the inner and outer wythes. In this case the wall will show no header courses, and it will not be apparent that it is a solid masonry wall.

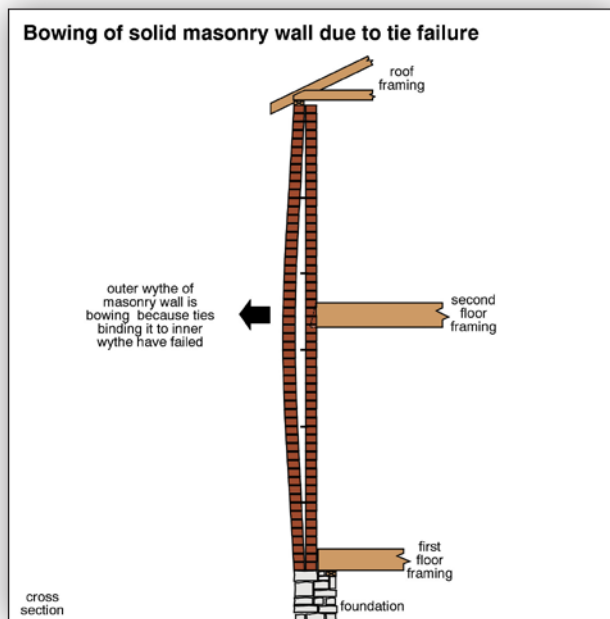
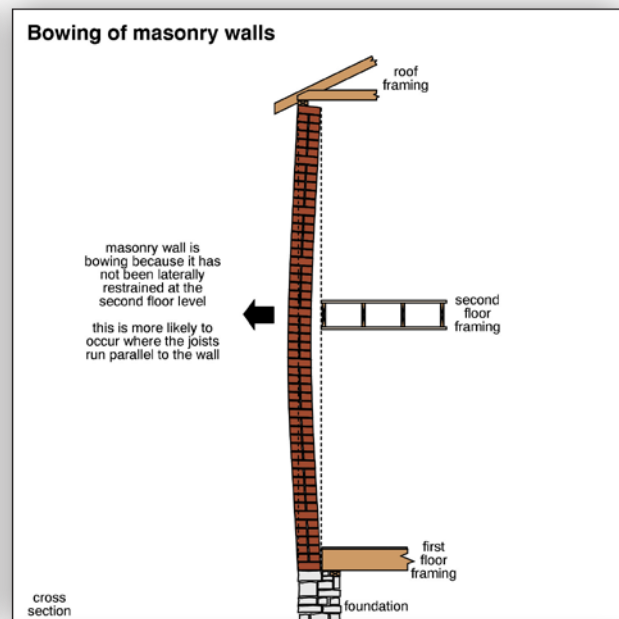
**LEAN/BOW** Where the inner and outer wythes are not adequately secured together, the outer wythes can lean or bow outwards. The entire brick wall may lean or bow due to foundation settlement or the wall not having adequate lateral support. Walls may also be pushed out of plumb by vehicle impact, for example. If a wall leans, the ultimate danger is that it may fall. The more immediate danger, however, is that the rafters and joists resting on the wall may slip off as the wall moves out away from the building. Since the ends of joists may only rest on the wall by an inch or two, a little movement can create an unsafe situation. If joists or rafters slip off their supports, the framing system will collapse.

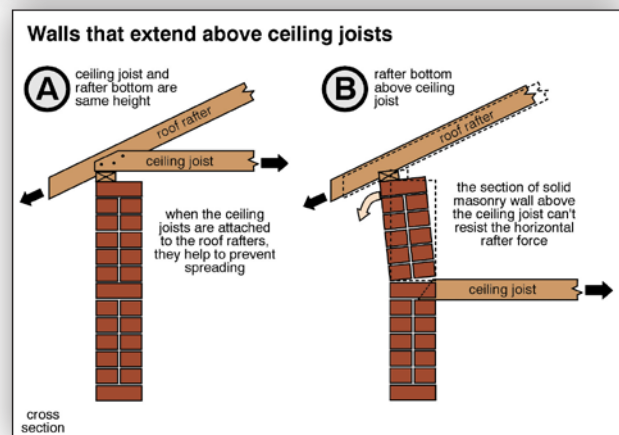
**RAFTER SPREAD** Spreading roof rafters may push the top of the walls out, resulting in an unstable situation.

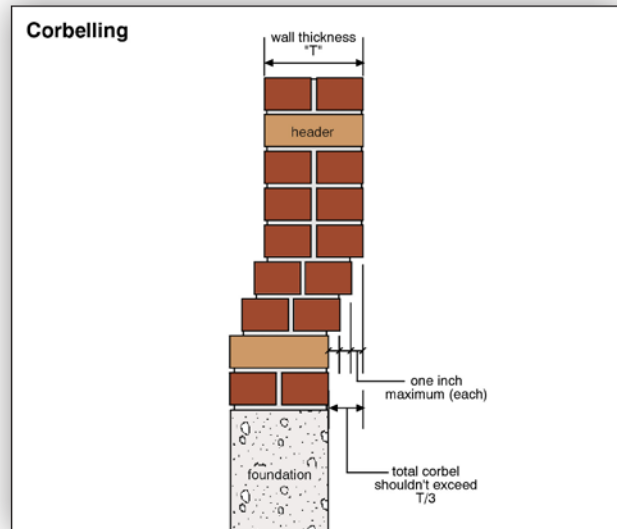
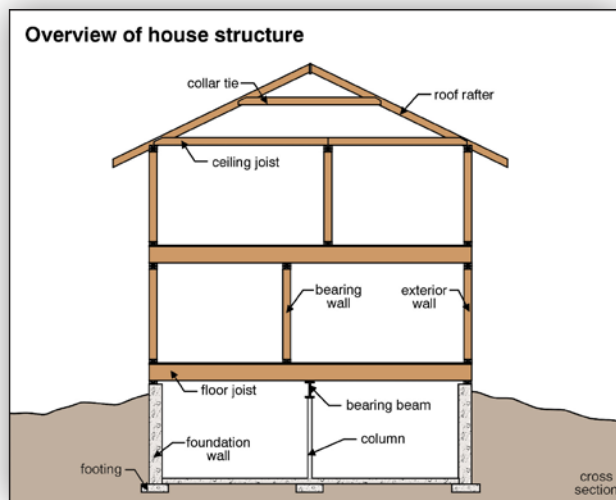
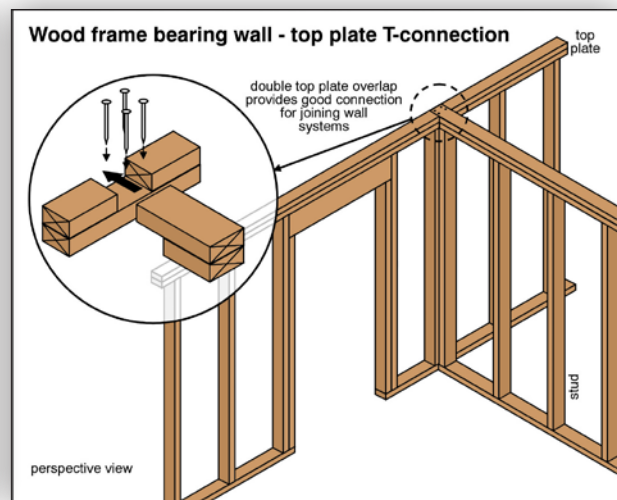
A single sole plate (also called sill plate or bottom plate) is provided in either case. None of this is visible once the home is finished.

Historically, 2x4 studs have been used, spaced 16 inches on center, although more recently, 2x6 exterior wall studs have become common as they provide more space for insulation between the studs.

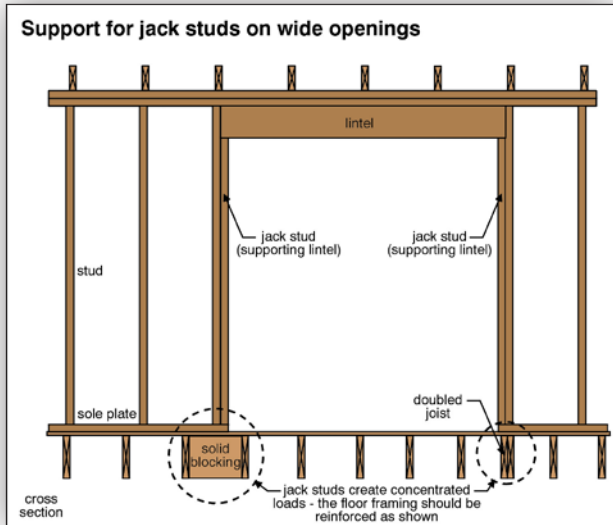
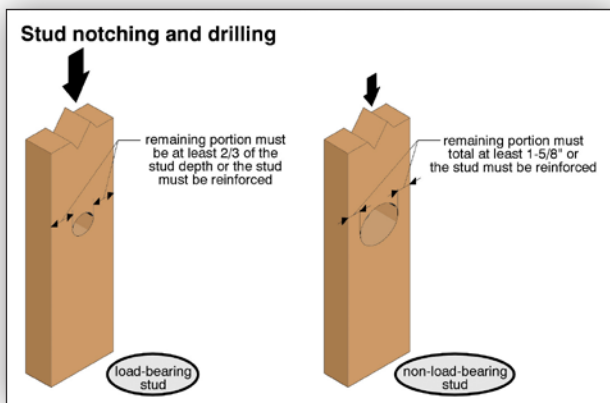
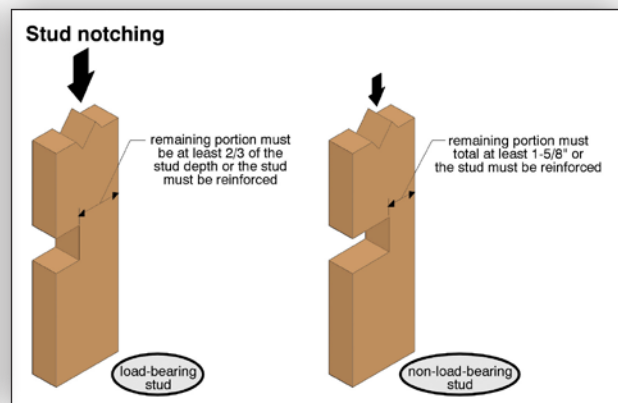
**NOTCHES AND HOLES** Holes and notches can weaken studs if they are too large. The illustrations below provide some guidelines.

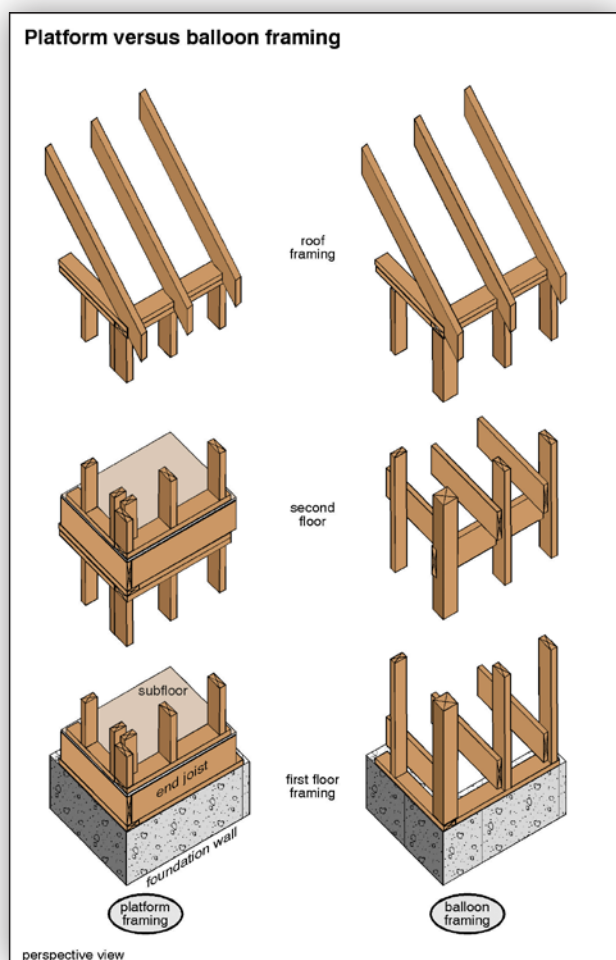
**6.1.2.2 Platform Framing:** Platform or Western framing is slightly different. A wood floor joist and subfloor system is provided on top of the foundations. One-story stud walls are built on the floor. If the house is two stories, a second floor platform is assembled on top of the studs, and then a second stud wall is built on top of this platform. This can be extended up to form a three-story house as well. The advantages of platform framing are ease of installation and lower material costs.

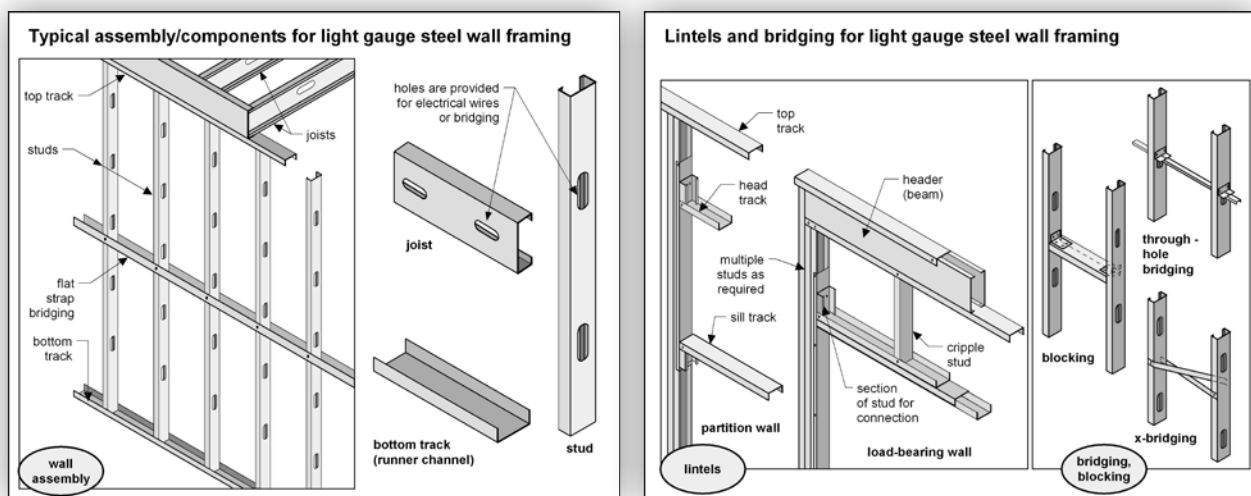
Structural framing elements are generally either C-shaped or U-shaped. C-shaped elements are designed as load-bearing elements, such as studs and joists, while the U-shaped pieces are tracks, or channels that hold the load-bearing components in place. In steel construction, tracks replace the sills and top plates used in wood-frame construction. Non-load-bearing walls are typically thinner, but are otherwise similar to load-bearing walls.

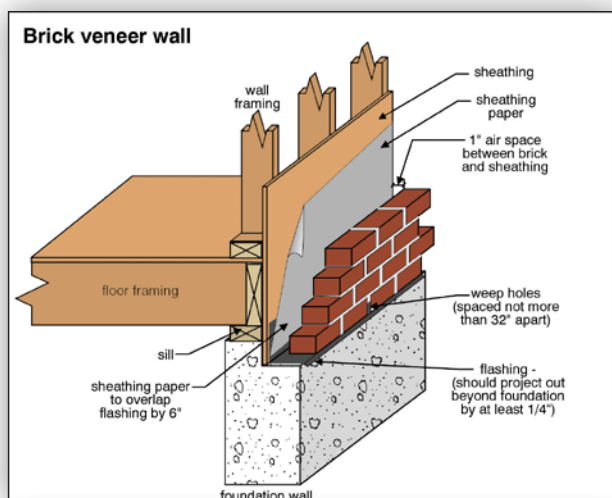
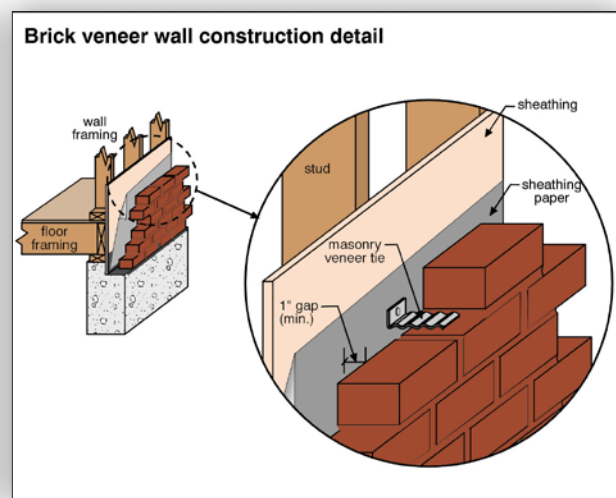
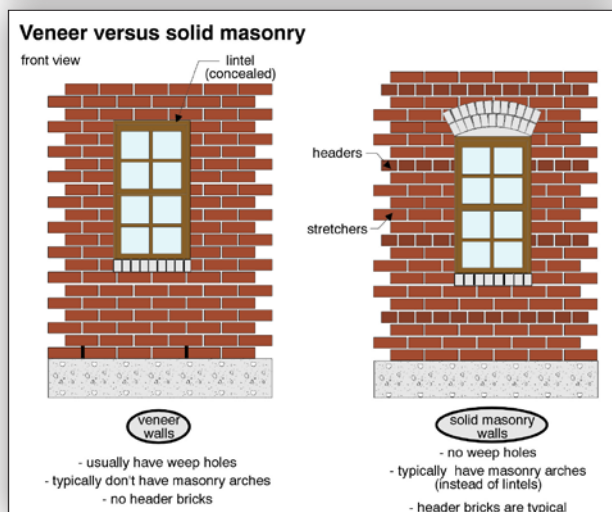
**6.1.4 Brick/Stone Veneer:** A brick or stone veneer wall has a structural wood (or metal) frame inner wall, and a four-inch thick masonry outer section (veneer), which does not have any load-bearing responsibility. Typically, metal ties are used to secure the masonry to the wood frame wall, and there are no header courses in the masonry. The absence of headers identifies a veneer wall in most cases. Most solid masonry walls have headers.

Veneer walls have been the most common masonry walls in single-family homes in many parts of America since about 1970.

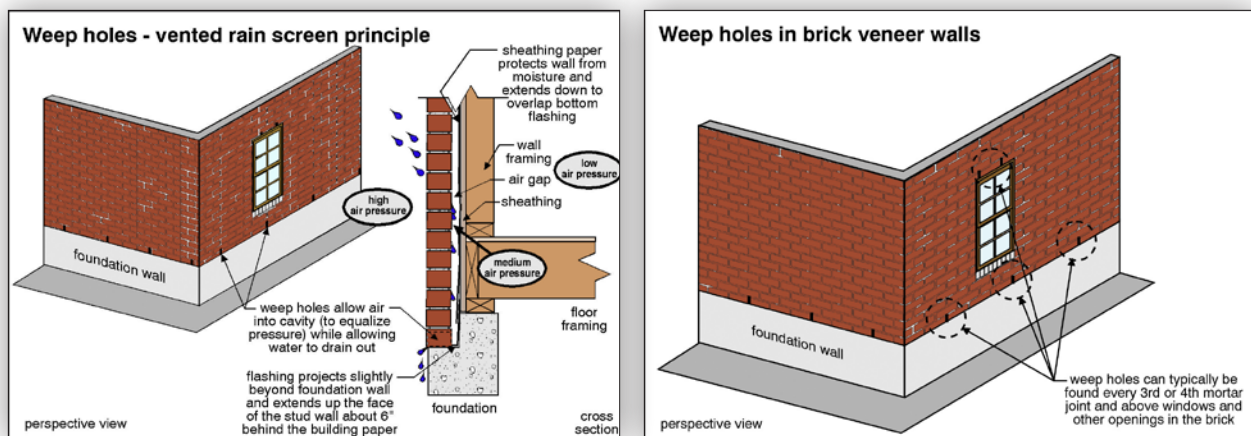
**RAIN SCREEN PRINCIPLE** Since the early 1970s, veneer walls have had weep holes provided at the bottom. A modern veneer wall uses a rain screen principle. This anticipates that wind driven rain will pass through a masonry wall, and as a result, a one-inch air space separates the masonry and the wood stud wall. Water runs down the inner face of the brick or the outer surface of the sheathing and drains out the bottom.

At the bottom row of masonry, every fourth vertical mortar joint (typically) is left open. A flashing at the bottom of the wall cavity directs water out through the weep holes. The flashing prevents the water from entering the foundation. Weep holes are also used above door and window openings.

A variation on weep holes is rope wicks in every fourth mortar joint in the bottom row of masonry. Where weep holes or wicks are noted, the wall is masonry veneer.
