# Structure

Final Analysis Property Inspections LLC

## INTRODUCTION

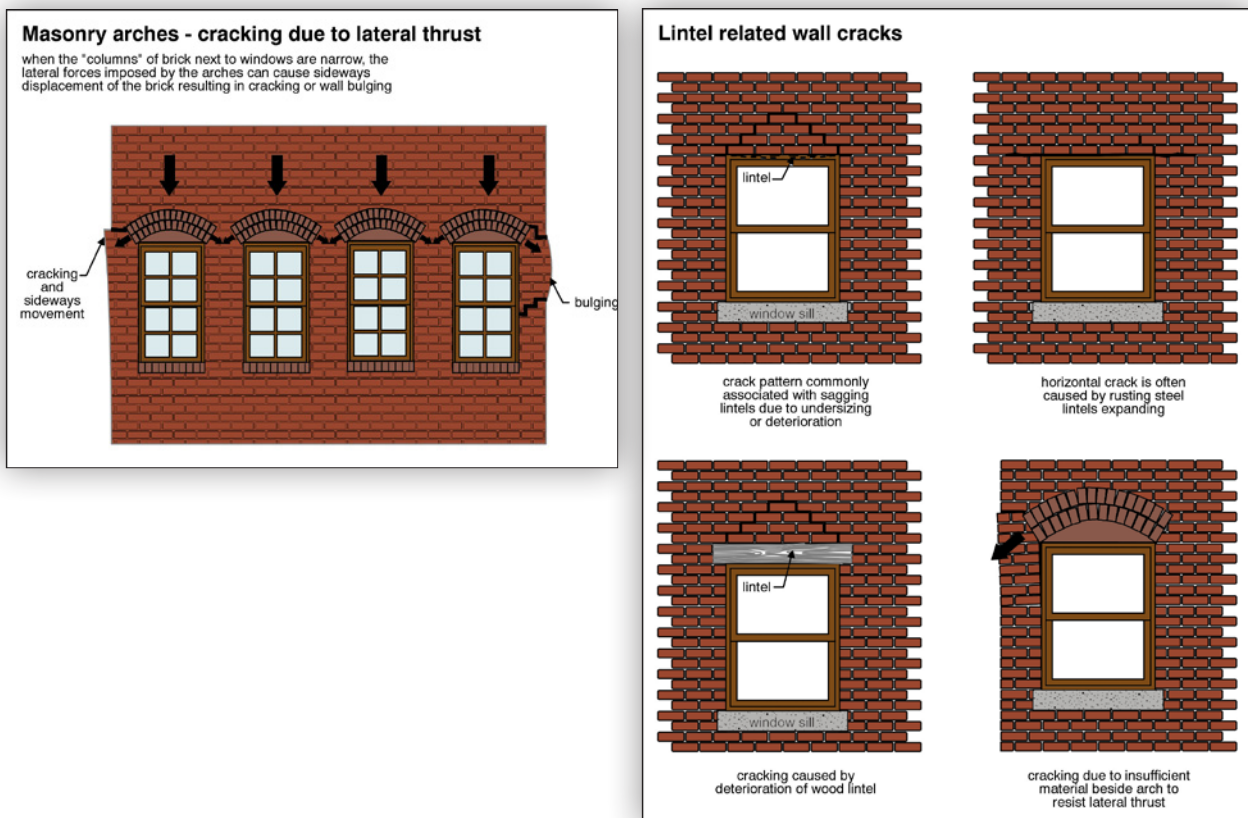
**TOO FLAT OR TOO NARROW** Failure in arches is common where the rise is very modest, or the arch is not quite wide enough to clearly span the opening. Another common problem with arches is slight movement of the walls on either side. This is particularly common where a window or door opening is close to the end of a wall. On one side of the arch, there may not be enough mass to resist the lateral thrust of the arch transferring its load to the wall beside. As the thin section of wall pushes outward, the arch drops.

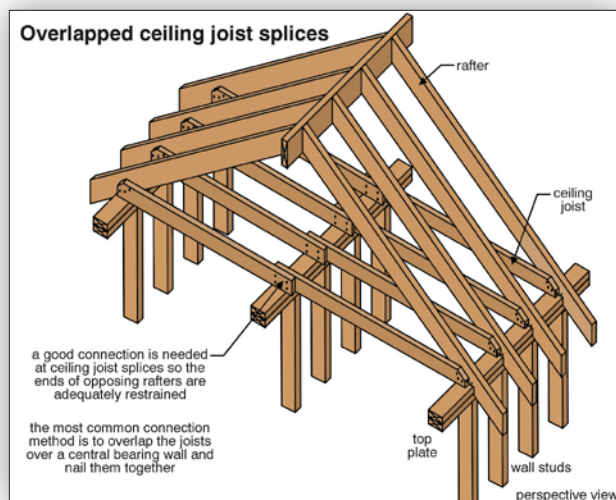
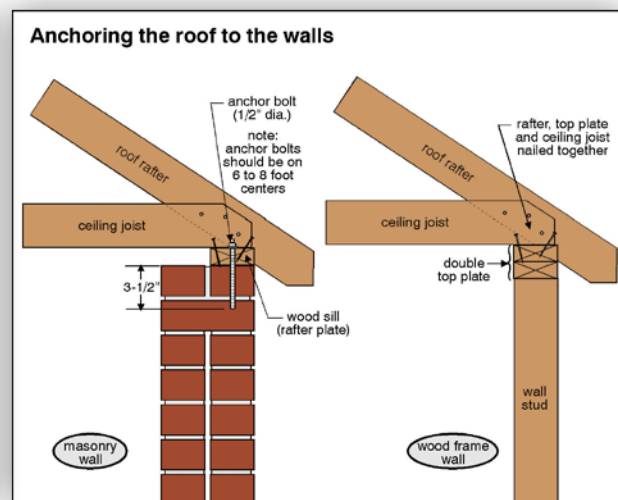
When calculating the span of a rafter system, the horizontal span rather than the actual length of the rafter is used. Knee walls or purlins may provide intermediate support, reducing the span. Collar ties help keep rafters in place. Ceiling joists are horizontal members that often tie the bottoms of opposing rafters together, making a strong triangle.

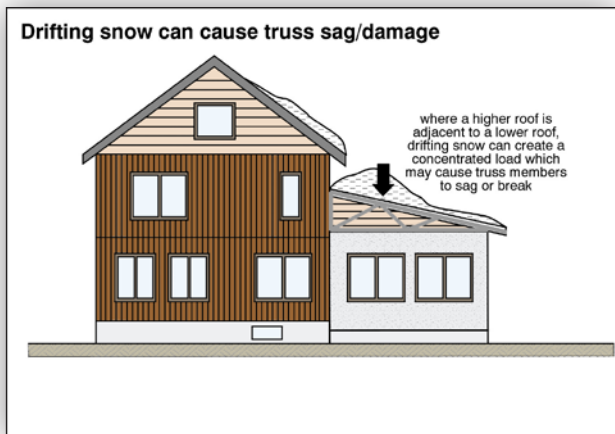
In cold climates, roofs may fail because of a concentrated snow load. Split-level houses are susceptible to this problem, for example. It is not unusual for snow drifts to form on the lower roof, near the wall of the higher section. This leads to big loads on the rafters or trusses in these areas. The rafters may crack, sag or spread at the bottom. Trusses may collapse.

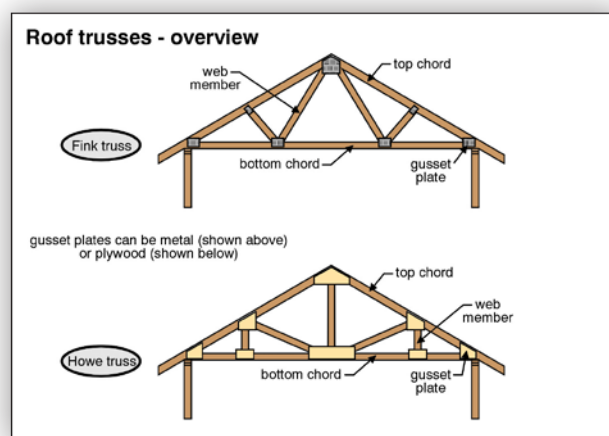
There are two common truss types used residentially. The Fink or “W” has web members that form a “W”. The Howe truss can be identified by vertical web members, including a vertical web running up to the peak. There are many variations of these found in residential construction.

In either truss type, the webs should be at least 2x4s, unless special engineering consideration has been given. Where the compression webs are longer than six feet, they are susceptible to buckling under heavy loads. Braces, such as 1x4s, should be fastened to the midpoints of these webs.

Where the bottom chord has a long span between support points, it may not be strong enough to carry the ceiling load. If the span is more than ten feet between support points, the bottom chord should be at least a 2x5. If the span is more than 12 feet, the bottom chord should be a 2x6. Again, special engineering consideration can result in deviations from these guidelines.

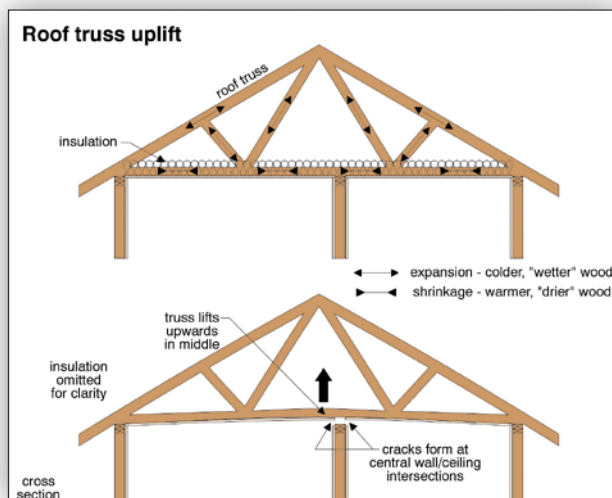
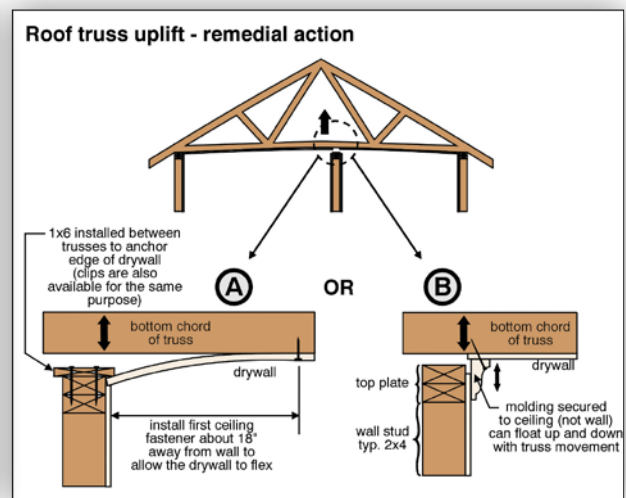
**TRUSS UPLIFT** A phenomenon known as truss uplift is relatively common in cold climates. The temperature and humidity changes in the attic during the winter months affect the sections of the truss above the insulation level differently than the bottom chord, which is buried in the insulation. This results in an upward bowing of the bottom chord.

Another solution is to disconnect the ceiling finishes from the truss during construction and to clip the ceiling finishes to the wall. This allows the ceiling to bend very slightly, but not to crack.

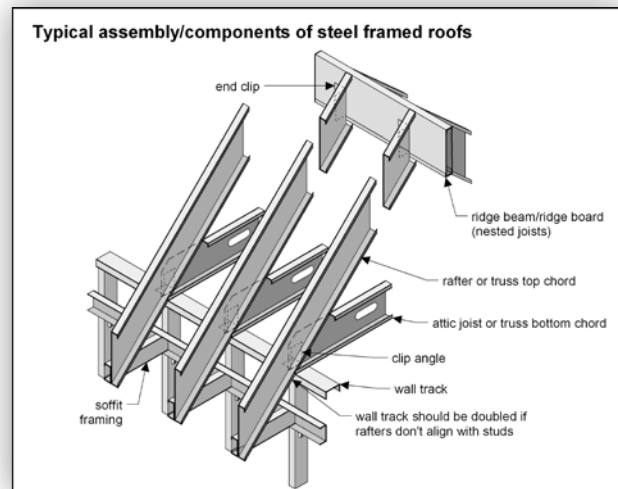
Steel roof framing performs very much like wood framing. Like wood, steel roof framing may be manufactured trusses or site-assembled rafters and joists. The principles of wood framing also apply to steel roof framing, although continuous bridging on the rafters is often needed, either on the underside, or through the knockouts. The undersides of joists will twist and move unless they are restrained.

Wood sheathing materials, such as plywood, are screwed to the steel roof structure. Roofing materials are installed over this sheathing as normal.

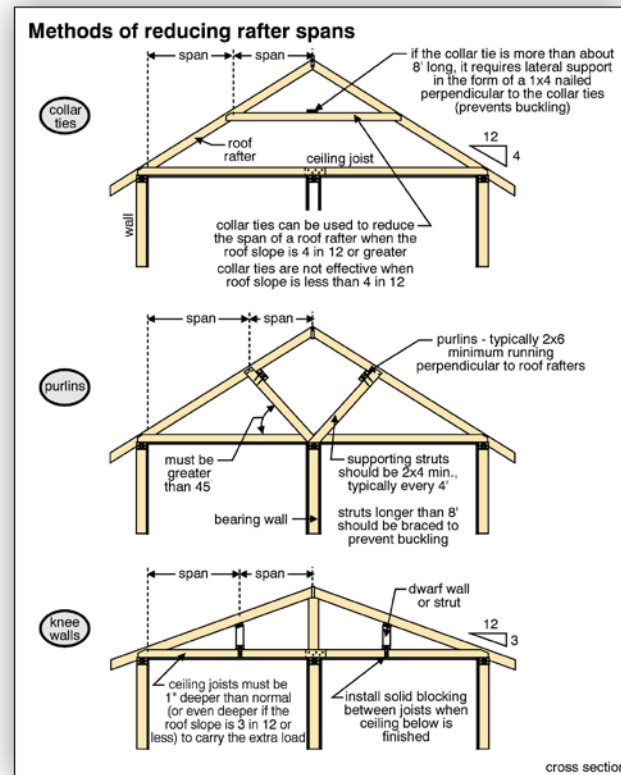
Knee walls are intermediate supports that prevent rafter sag. These small walls in the attic are typically built with 2x4 wood studs. They run from the attic floor up to the underside of the rafters near their mid-point. In 1-1/2 or 2-1/2 story houses, knee walls form the walls of a room on the upper floor. These rooms often have a partly sloped ceiling as a result.

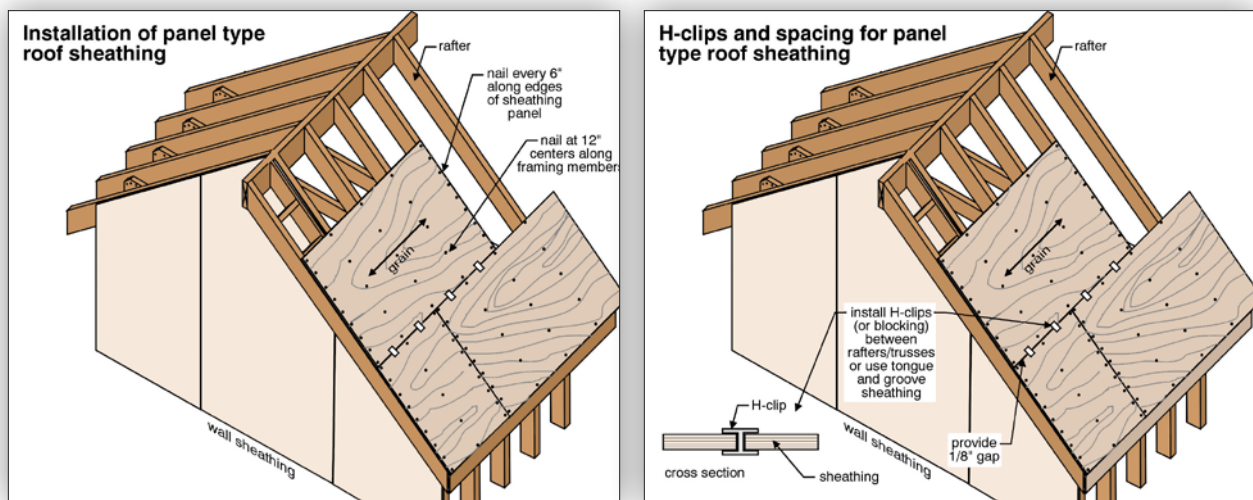
Plywood should be laid with the surface grain perpendicular to the rafters, trusses or joists. The eight-foot length should be across the rafters with each end supported by a rafter. The other edges should also be supported, typically by metal “H” clips located between rafters. These clips not only support the edges, but keep the sheets slightly separated to allow for expansion without buckling.

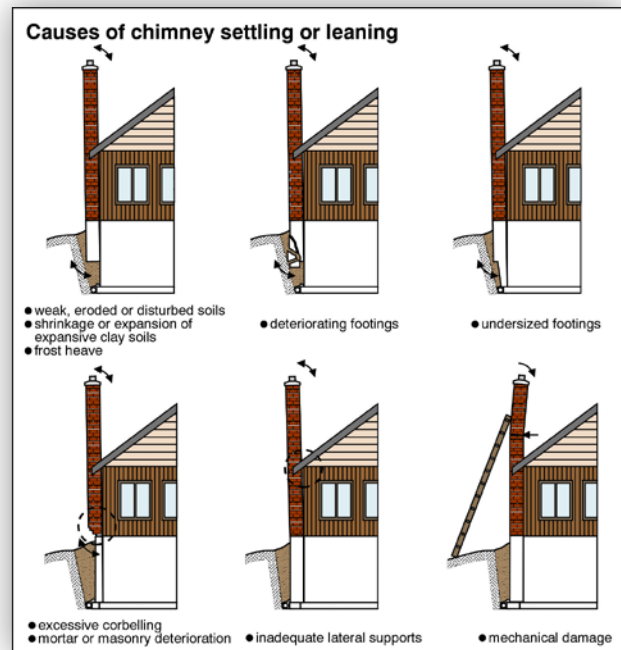
**CORBELLING** Chimneys with excessive corbelling (one row of bricks projecting out and overhanging the row below) or undersized foundations are prone to movement. (See Section 6.1.1)

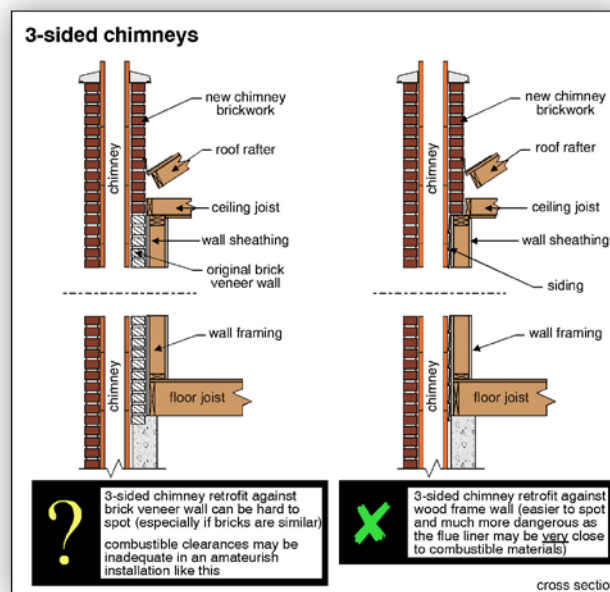
**CONTACTING CHIMNEYS** Generally speaking, interior wood should be at least two inches from the chimney. On exterior wood, this can be reduced to 1/2 inch. Where it is necessary to frame into the chimney, there should be 12 inches of solid masonry between the wood and the flue.

**FIREBLOCKING MISSING** The space between masonry chimneys and wood framing can provide a channel for fire to move quickly up through house. Fireblocking at ceiling levels helps prevent this. The blocking material can be compressed fiberglass insulation or other non-combustible material. It is often difficult to see during a home inspection whether this has been installed.
